ŚWIATOWIT

VOL. XI (LII)
(2013)

DEFENSIVE WALLS OF CHERSONESOS TAURICA. AN ANALYSIS OF DESTRUCTION AND RECONSTRUCTION TRACES

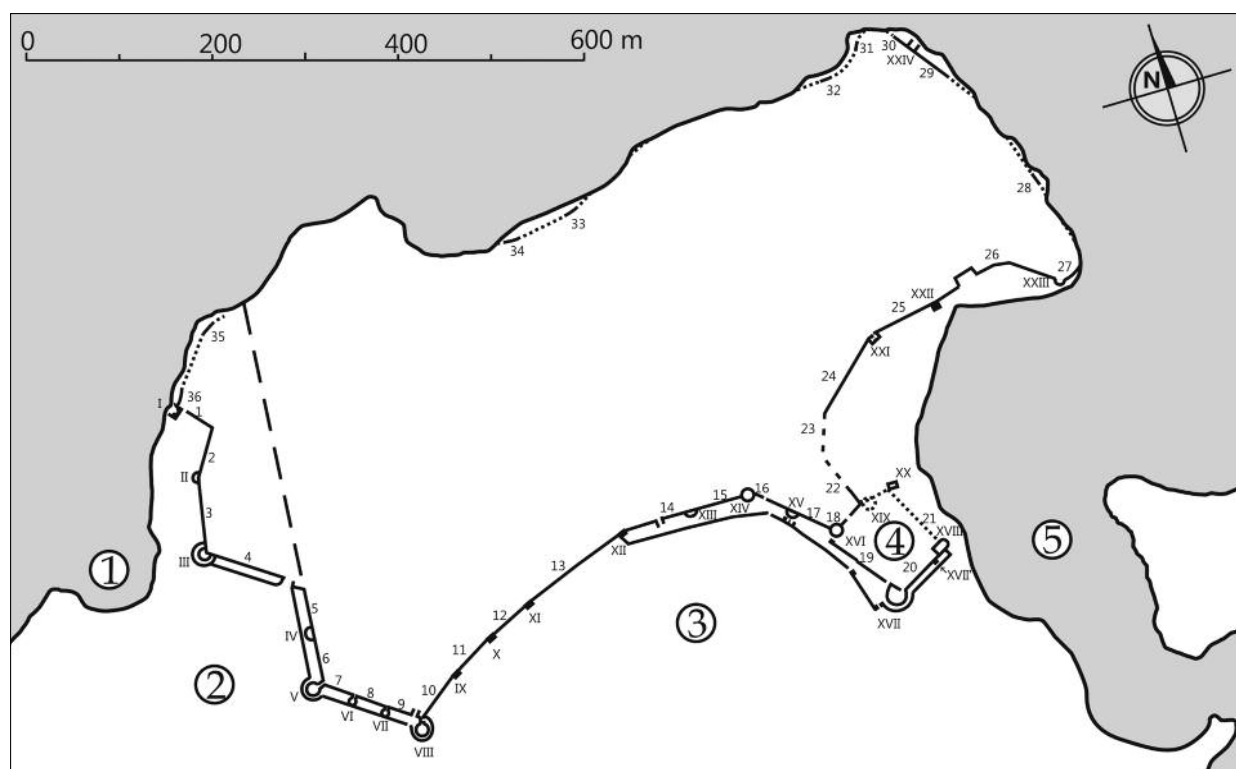
Fig. 1. Chersonesos Taurica. General plan. Curtains of town walls are marked with Arabic numerals and turrets are marked with Roman numerals (after: BERT'É-DELAGARD 1907, drawing P. Zakrzewski). 1 – Pesočnaâ Buhta (Sandy Bay); 2 – Pesočnaâ Balka (Sandy Ravine); 3 – Karantinaâ Balka (Quarantine Ravine); 4 – Citadel; 5 – Karantinaâ Buhta (Quarantine Bay).

Only blocks of the face within accessible parts of the defensive walls underwent measurements. These were faces of Curtains 16, 17 and 19, with Turrets XV, XVI and XVII, as well as with a wicket in Curtain 19, which led to the area of the citadel (Fig. 1).

Surviving vestiges of the walls are a very complex structure. They include remains of a number of curtains and turrets, and each of these shows traces of various building phases. Architectural remains which have survived until now are situated mainly in the south-eastern part of the fortifications of the town. In the course of centuries, curtains and turrets were rebuilt and extended in two different ways. Some of these were provided with superstructures for many times and thus remains of subsequent phases are situated one above the other. This phenomenon can be seen in the case of Curtains 16, 17 and partially 19, as well as in Turret XVI. Providing this part of the defences with superstructures was a well-considered solution and was related to a steady accumulation of sediments in the foreground of the fortifications. The reason behind this phenomenon was a periodical flow of water in the bottom of a nearby ravine (cf. KARASIEWICZ-SZCZYPIORSKI 2014 – this volume, 87–112). The mentioned part of the walls crossed the mouth of Quarantine Ravine (Karantinaâ Balka) to the bay of the same name (Fig. 1).

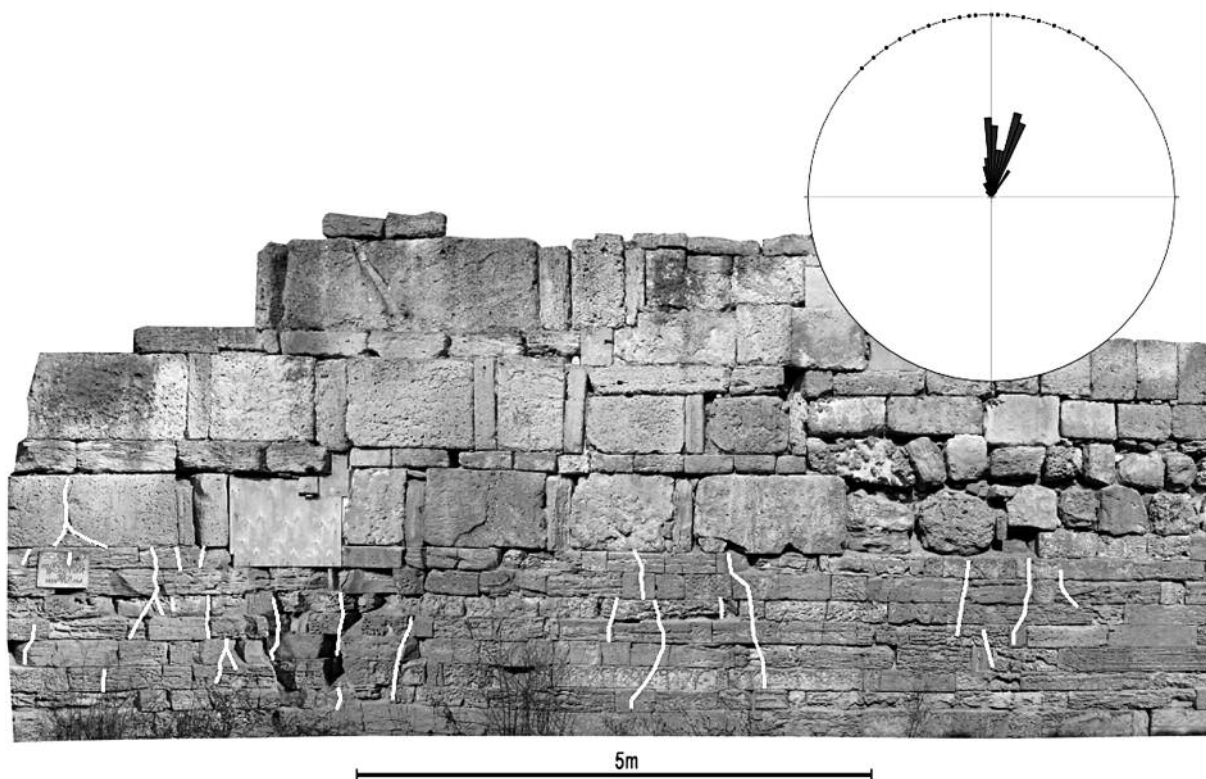
Fig. 3. Part of Curtain 19 with a directional graph of fissures (Photo R. Horosz, processing U. Zawadzka-Pawlewska).

Destructions which can be seen in the defensive walls of Chersonesos are similar to the aforementioned examples from Macedonia and Bulgaria. This is especially well-visible in the case of fissures. Rosette diagrams which are an element of interpretation of measurements of fractures in masonry walls demonstrate that the course of fissures is similar to that which was caused by earthquakes in other territories (Figs. 2–4; DADLEZ, JAROSZEWSKI 1994).

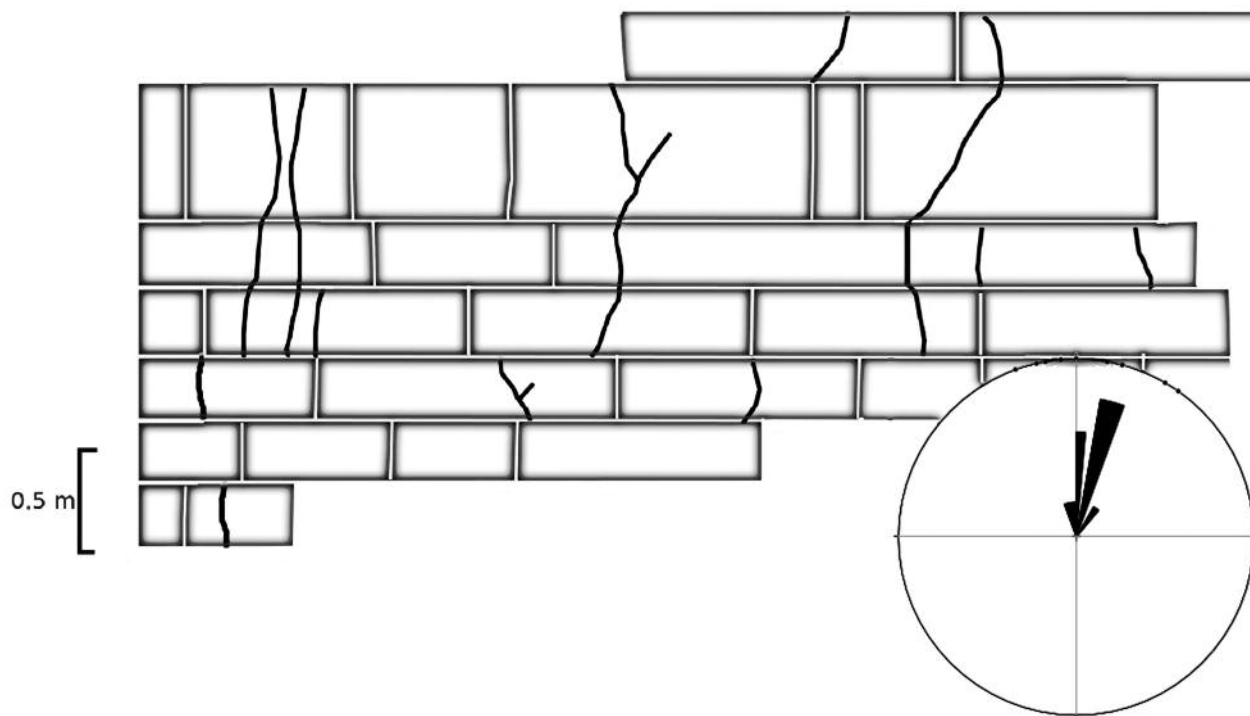
Fig. 4. Western pylon of the gate in Curtain 16 with a directional graph of fissures (Drawing U. Zawadzka-Pawlewska).

Surviving remains of the defensive walls of Chersonesos bear traces of numerous damages which may be classified as seismic destructions. The most evident examples with regard to that are provided by Curtains 16 (Fig. 2) and 19 (Fig. 3), as well as the western pylon in the gate in Curtain 16 (Fig. 4) (cf. ANTONOVA, NIKONOV 2009: 18, 20).

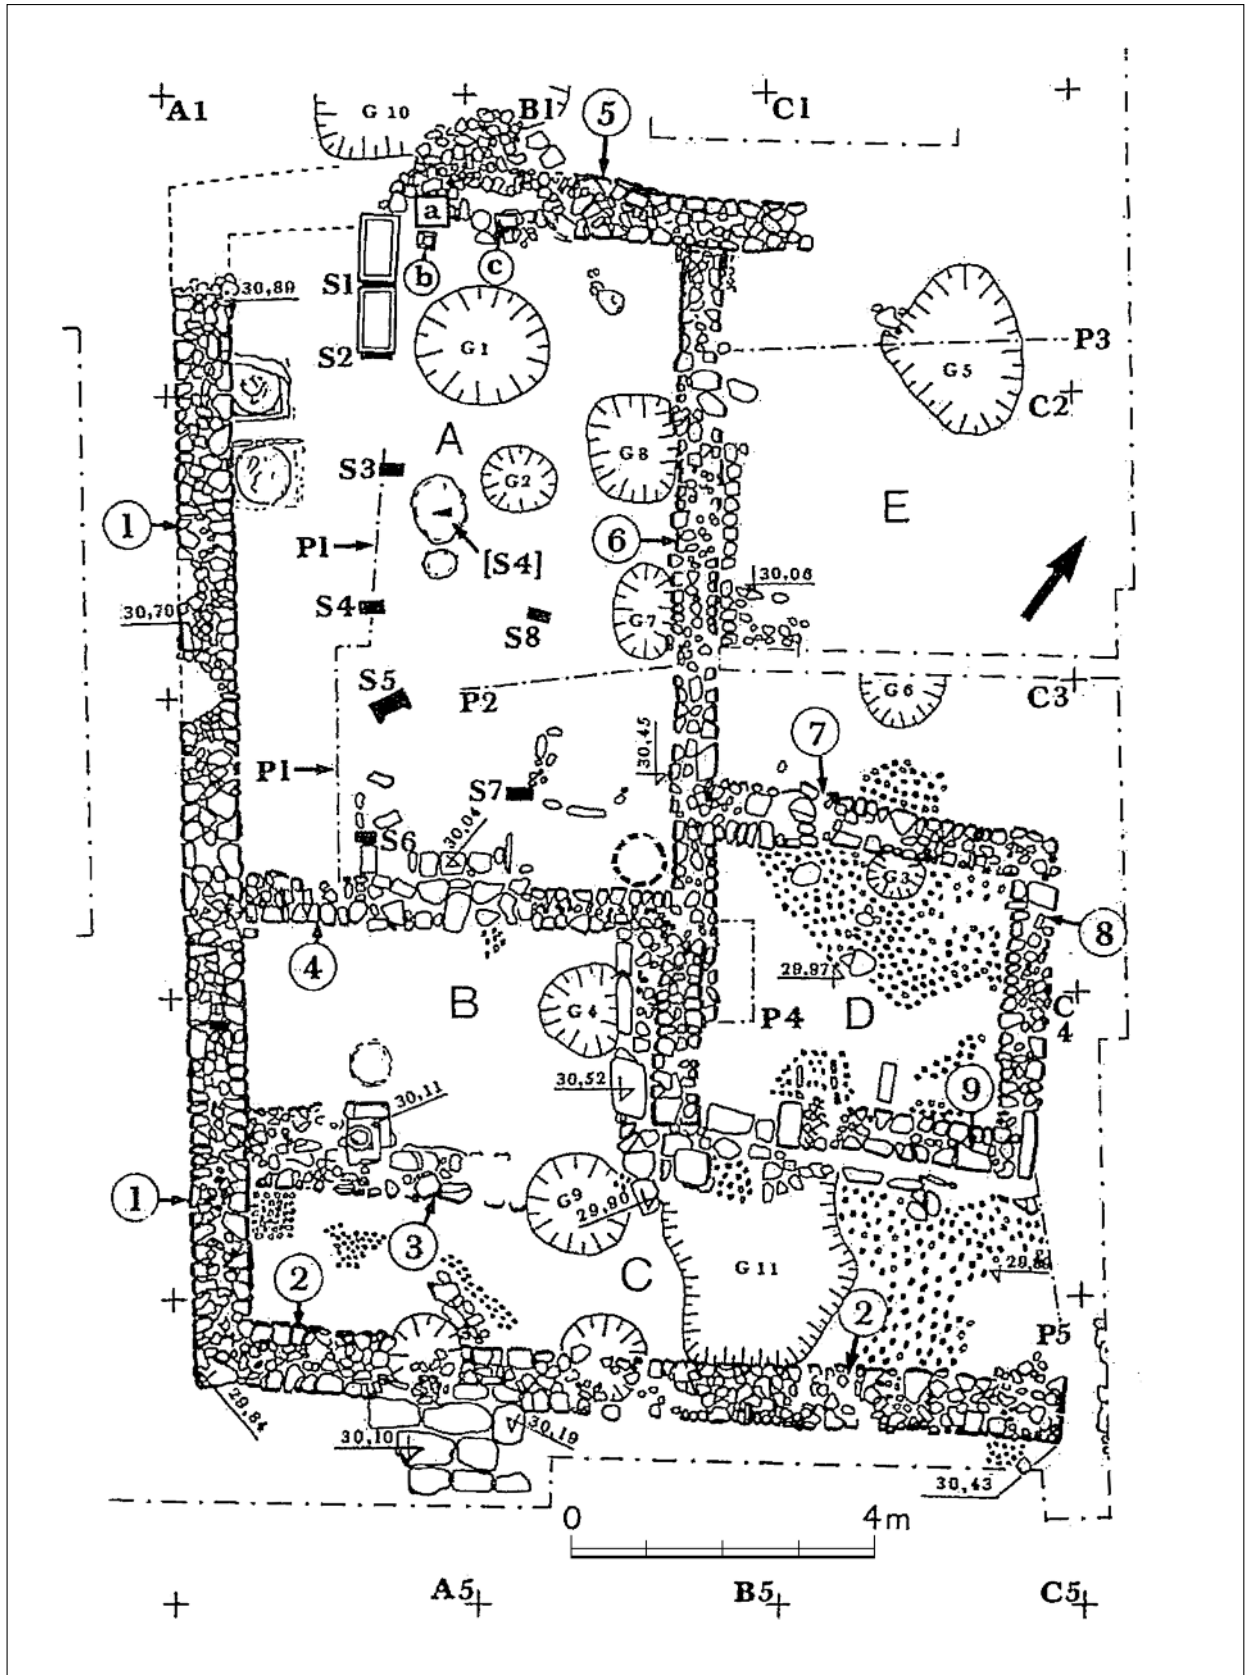
Fig. 6. Balaklava. Plan of the Temple of Jupiter Dolichenus (after SARNOWSKI, SAVELJA 2000: fig. 6).

(SARNOWSKI, SAVELJA 2000: 57). The authors of the present paper believe that these suggested reasons do not seem sufficient. The accumulation of layers should rather cause forces acting evenly in various directions. Furthermore, these forces should be counterbalanced by the accumulation of layers outside the collapsed building. Traces of destructions which are noticeable at the site indicate that the impact of the forces was very uneven. Wall 1 deviated to outside and probably pulled the structure of the roof with itself. Due to this, damage was done to the opposite load-bearing Wall 6. The deviating Wall 1 must have broken off from the transverse Wall 4. Perhaps a fissure also occurred in the interface of Walls 1 and 5 (the wall with an apse). Regrettably, the corner of the temple did not survive.

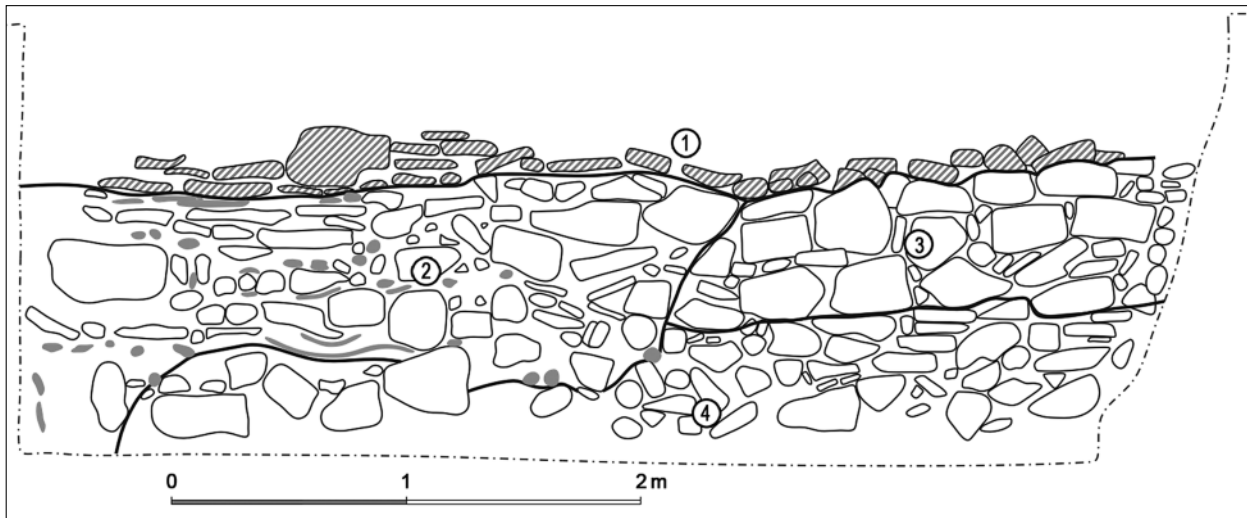
Fig. 7. Balaklava. Face of the rebuilt external foundation of the *Praetorium* (elaborated by R. Karasiewicz-Szczypiorski, drawing J. Kaniszewski). 1 – remains of the external wall at the level of the ground floor (Phase 3); 2–4 – foundation of the building (Phase 3): 2 – part of the foundation which came into existence during the construction of Phase 3, 3 – remains of the external wall at the level of the ground floor (Phase 2), 4 – remains of the foundation of the building (Phase 2).

Traces of repairs of the masonry wall of the another building at Balaklava – the so-called “barracks”, later identified as the *praetorium* – may be a testimony of removal of results of this cataclysm. The mentioned building was ranked to the same building phase as the Temple of Jupiter. The (southern) wall of the mentioned building was dismantled nearly to its foundation footing and then it was reconstructed (Fig. 7). This is only one of elements constituting the image of an extensive rebuilding of the *Praetorium* at the beginning of the 3rd c. AD (KARASIEWICZ-SZCZYPIORSKI, SAVELA 2011: 174; 2012: 175–176, figs. 1, 6; 2013: 127–131, figs. 7–12; 2014: 163–172). Perhaps this rebuilding resulted not only from the exchange of garrisons at the turn of the 2nd and 3rd c. AD, but was also forced by a need for repairing of destructions caused by an earthquake. Also at the site of Kazatskaya Hill poorly identifiable traces of destructions were recorded. These were remains of roofing tiles and pieces of charcoal, which were trodden into the floor inside the watchtower (WRÓBEL, PIĄTKOWSKA-MAŁECKA, KARASIEWICZ-SZCZYPIORSKI 2012: 102, fig. 3:3). Also in a part of rooms which accompanied the tower and were built in the court-yard two usage levels are legible. These are separated with a layer of pure clay, which came into existence in all probability in result of the collapse of walls of the mentioned rooms. Of course, it is not possible to unequivocally say that an earthquake was responsible for the mentioned destructions.

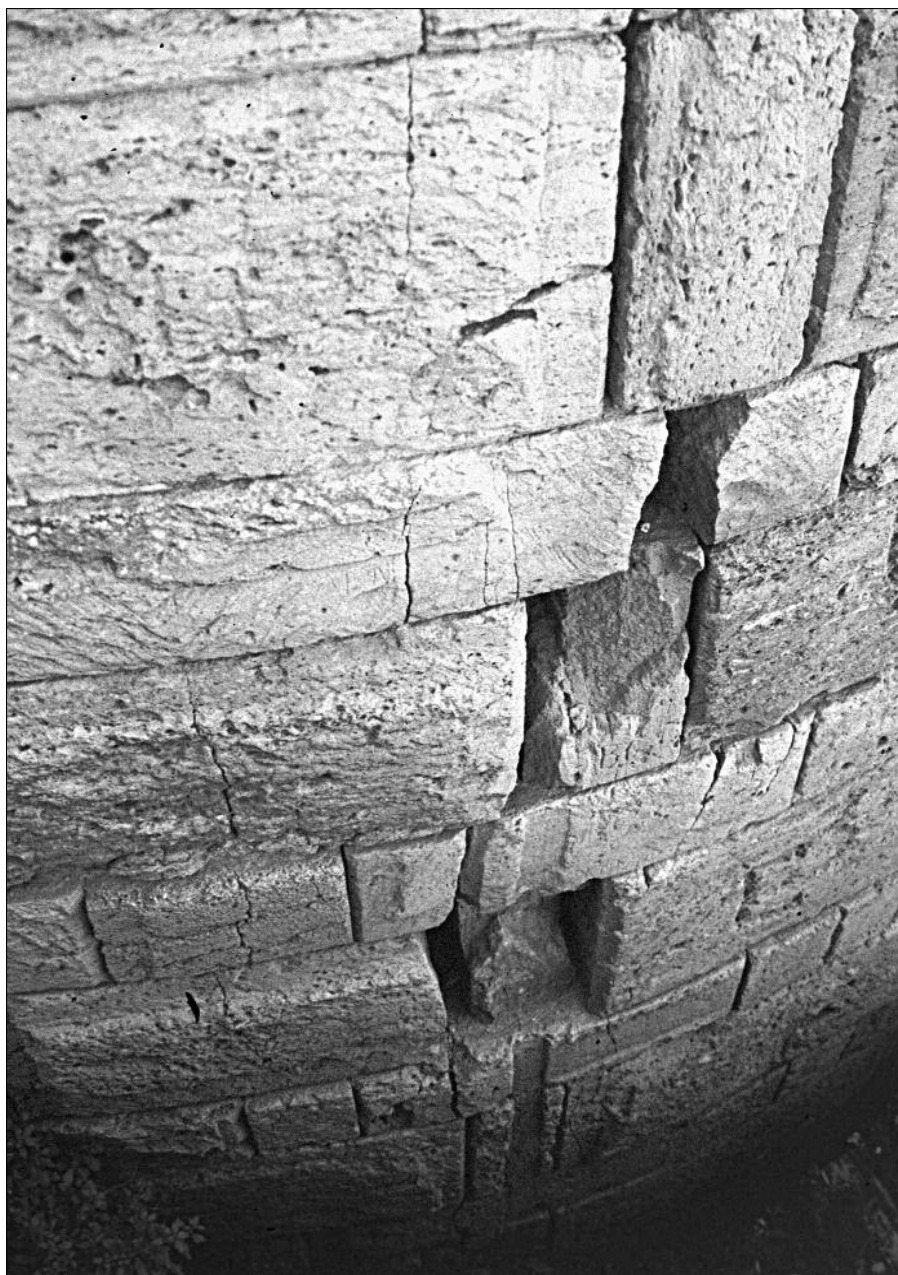
Fig. 8. Chersonesos – the citadel. Turret XVII – the face of the so-called “core of the turret” with a clearly visible fissure and sliding apart of blocks (Photo R. Karasiewicz-Szczypiorski).

A peculiar fracture of the “core” of Turret XVII in Chersonesos (Fig. 8) has already been noticed by Berthier de Lagarde (BERTHIER-DELAGARDE 1907: 121). This scholar remarked that there were no similar traces on a reinforcement (called “the first thickening”) surrounding the origi-

nal structure of the turret. Based on this, one can consider this thickening as a trace of repair of earlier destructions. The first mentioned extension of the turret is dated to the end of the 3rd c. BC (ZUBAR, ANTONOVA 2001: 50) or to the beginning of the 2nd c. BC (STRZELECKIJ 1969: 16). It is worth stressing that an earthquake as a possible reason of damage of the “core” of Turret XVII was first suggested only by Antonova (1996: 119). This hypothesis was later confirmed by Nikonov. On the other hand, this researcher related traces of destruction to seismic activity in the Roman period in a completely erroneous manner (ANTONOVA, NIKONOV 2009: 20).

The later origin of the fissure in the "core" of Turret XVII and cracks in the wall of the earliest phase of Curtain 19 can in all probability be linked in time (contra Nikonov – see ANTONOVA, NIKONOV 2009: 20). These are perhaps results of the same earthquake. A small extent of damages to Curtain 19 as compared with Turret XVII may result from the same reason as in the case of the leaning Turret XVI. The part of the mentioned curtain which adjoined the turret was also founded on sediments deposited in the ravine. Thanks to this, it was more resistant to vibrations.

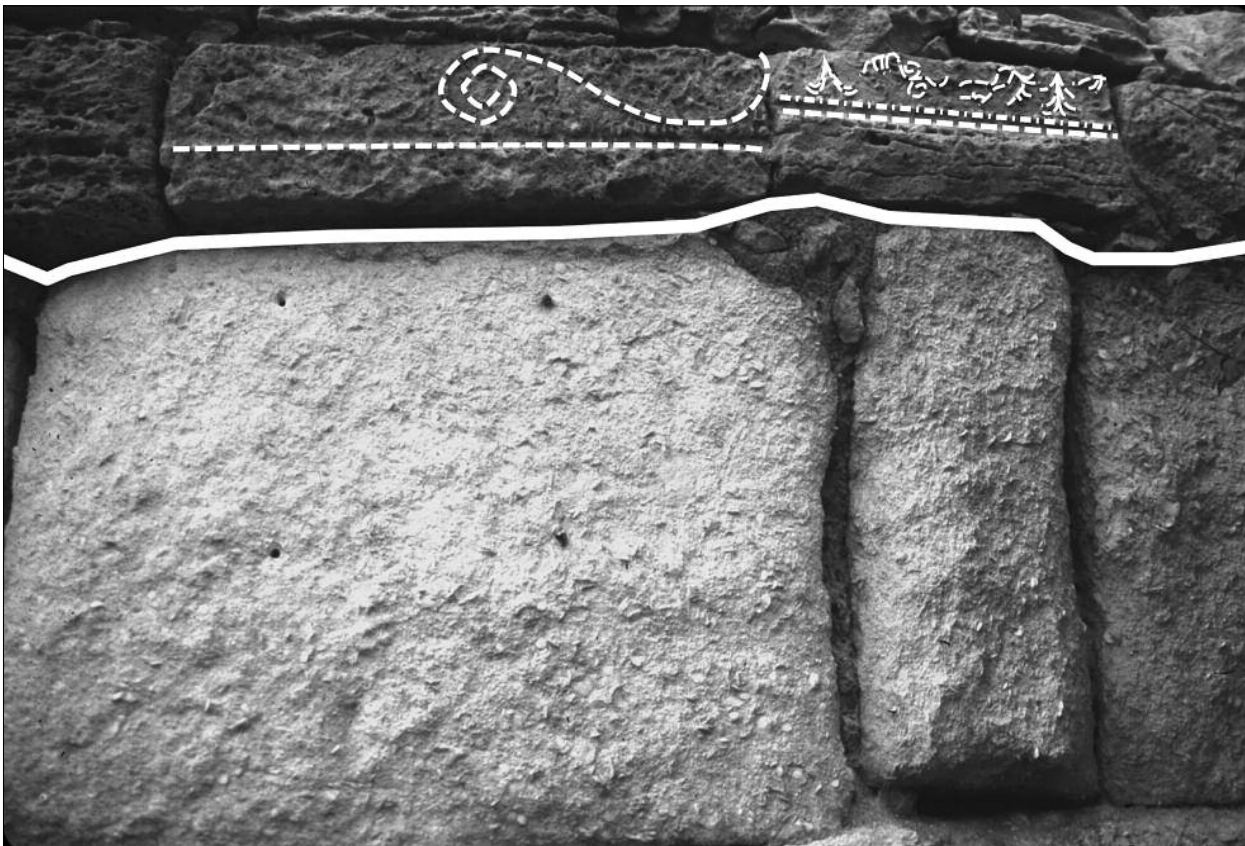
Fig. 9. Chersonesos – the citadel. Turret XVI – the so-called first thickening. Secondly used architectural details can be seen (Photo R. Karasiewicz-Szczypiorski).

5. The turn of the 3rd and 4th c. AD. The buttress was built on to Turret XVI on the side of the citadel. Monumental architectural details were used in the construction of this reinforcement. These may have come from a building destroyed during the same seismic episode which caused the mentioned turret to lean.
